# Geomorphology of the Nechako River

## NWR Spring Technical Meeting

## Nechako River Geomorphic Assessment

Geomorphic Atlas | Final

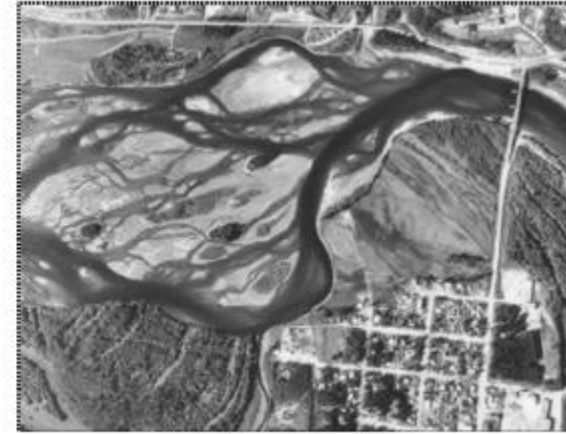
1966 ( $96 \text{ m}^3/\text{s}$ )

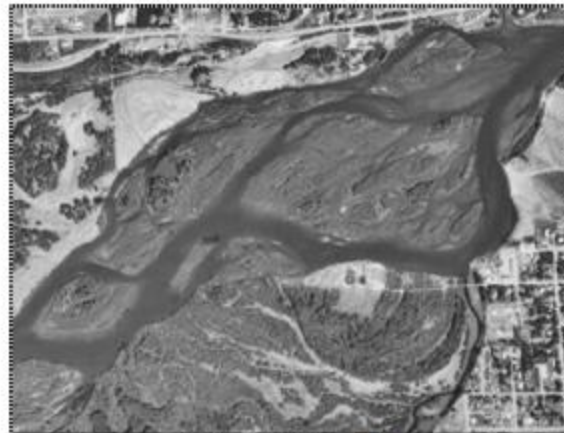
1985 ( $175 \text{ m}^3/\text{s}$ )

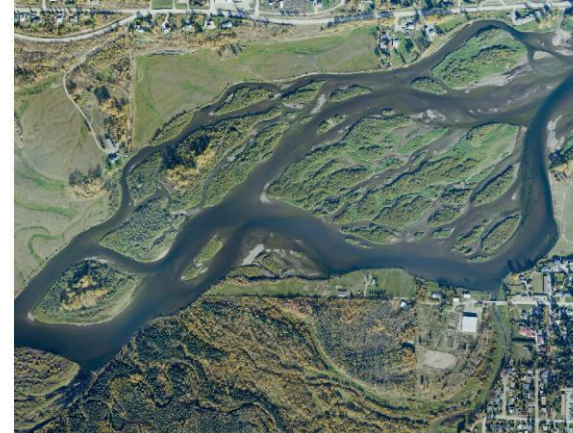
2021 ( $92 \text{ m}^3/\text{s}$ )
